# Manhole Inspection Summary

Manhole # S11E1\_002MH

Insp Date: **4/9/08 12:02 PM**

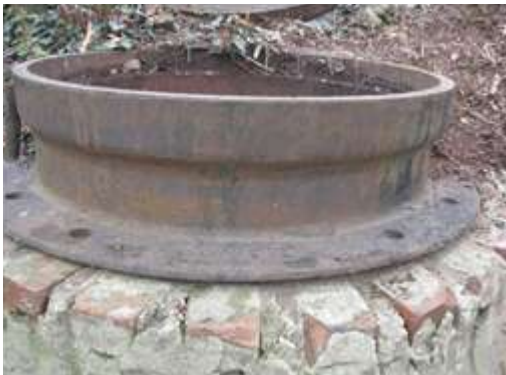
Misc

frame side view

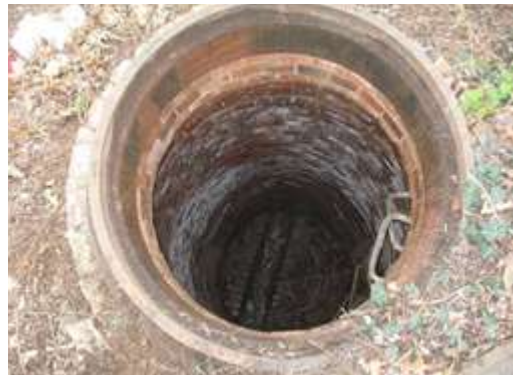
Misc

frame view

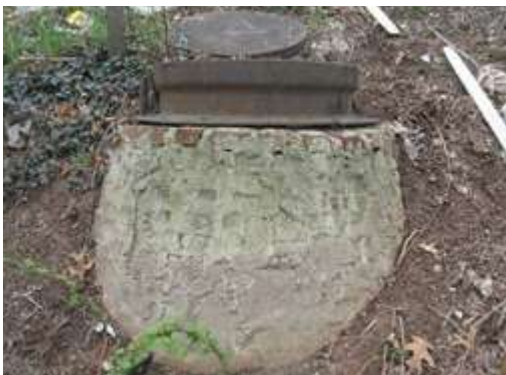
Defect 1

**Cover** Shape: **Circular** Diameter: **32** (in.) Length: **0** (in.) Dist A/B Grade: **40** (in.)

above grade 40 inches

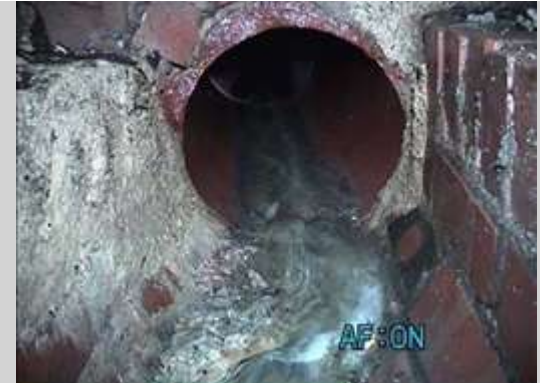
12 O'Clock Outflow

10 in. Circular Gravity Sewer  
Pipe Out @ 12 O'Clock

Pipe Height: **9.6** (in.) Rod and Bar (Angled)  
Pipe Material: **Clay** ☐ Pipe Lined  
Invert Depth: **13.36** (ft.) Flow Characteristics: **Slow**  
Deposits: ☒ None ☐ Mud ☐ Sludge ☐ Debris ☐ Grease  
Silt Depth: **0** (in.) Deposits Extent:  
Infiltration: **None** Pipe Seal Cond: **Sound**

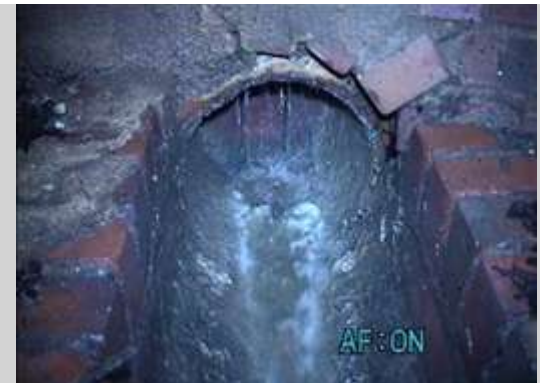
6 O'Clock Inflow

10 in. Circular Gravity Sewer  
Pipe In @ 6 O'Clock

Pipe Height: **9.6** (in.) Rod and Bar (Angled)  
Pipe Material: **Clay** ☐ Pipe Lined  
Invert Depth: **12.92** (ft.) Flow Characteristics: **Slow**  
Deposits: ☒ None ☐ Mud ☐ Sludge ☐ Debris ☐ Grease  
Silt Depth: **0** (in.) Deposits Extent:  
Infiltration: **None** Pipe Seal Cond: **Sound**
